**Case Reference.**

**3517**

**Sugar Auger**

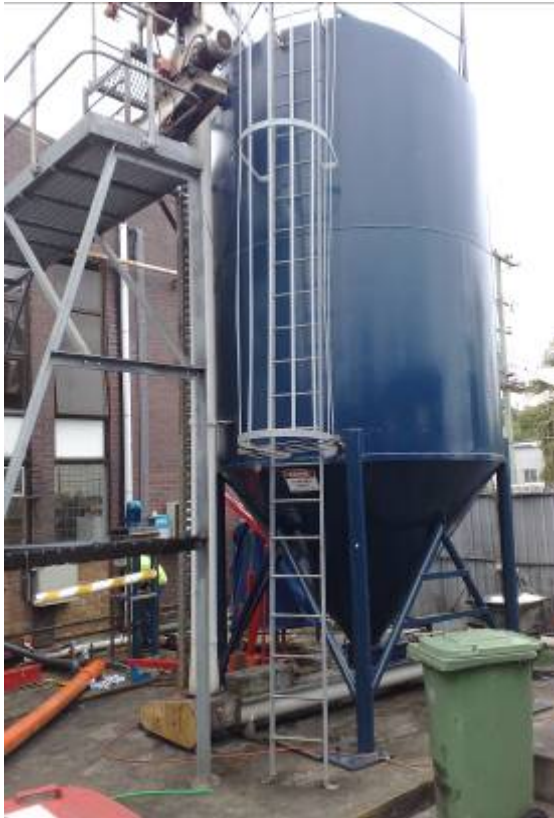
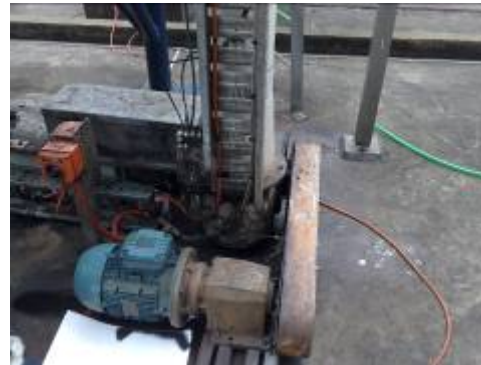
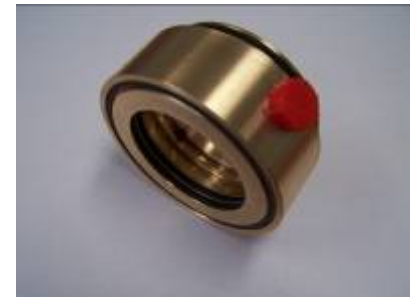
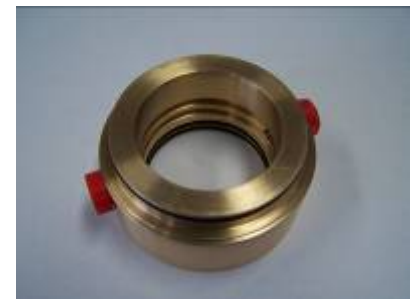
A beverage manufacturer in Australia had problems with bearing failures on their sugar auger caused by ingress and due to the very abrasive nature of the sugar.

The original sealing arrangement was by way of lip seals and bearings were being changed every maintenance shut down.

In October 2008, the auger's bearing sealing arrangement was upgraded to a LabTecta IAP - 2.000" x 2.500" - eliminating all problems. Labor costs and machine downtime have been reduced drastically and the LabTecta has been operating successfully since installation.
