## Changing The Lube Environment Solves Problems

By: Alan Roddis B.Eng (Hons), M.Dip

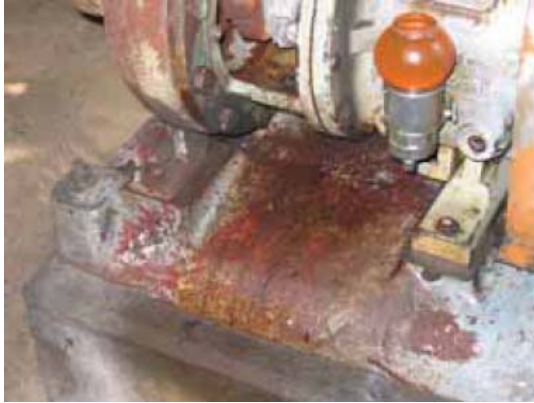
Fig 2.3 - Bearing lubricant leakage from an unbalanced lubricator.

For many years, plant engineers have fitted unbalanced oil lubricators to accommodate losses in oil lubricant during equipment operation, as shown in Fig 2.3. Lubricant losses are typical when the equipment uses lip seals. However, if the losses are curtailed by simply using modern bearing seals, the need to top up the oil is greatly reduced or even eliminated.

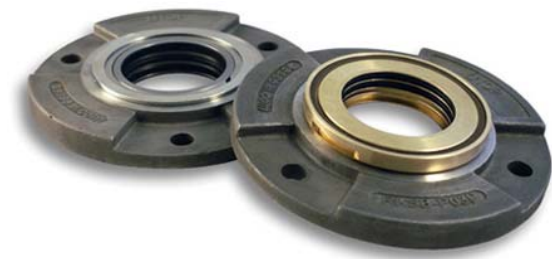
Fig 5.1 – Bearing Caps with bearing seal installed

Fig 5.1 - 5.3 illustrates such an elastomeric sealing means, whereby an innovative elastomer design, supplied by AESSEAL plc, is employed to seal the bearing chamber of the KSB-CPK P02 to P05 range of process pumps.

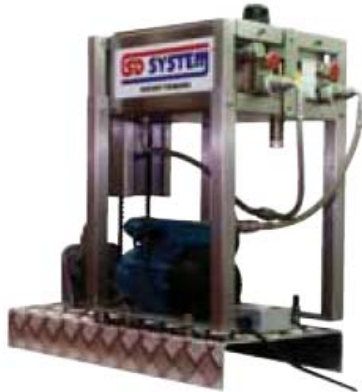
Fig 7 – Bearing Lube circulation system

SD System  
(Forced Lubrication System)

An alternative method of dissipating the heat from the bearing chamber is to employ in a forced lubrication circulation system as shown in Figure 7 below.

From Figure 7, bearing lubricant is circulated via a forced circulation system using a patented belt-drive mechanism from the equipment shaft. This lubrication means has no additional electrical supply and has the advantage of a vastly greater surface area compared to a conventional bearing chamber, so as to improve the heat dissipation for the bearing lubricant.
